# Baumhart Road and Industrial Parkway

## Abbreviated Safety Study

April 30, 2021

Abbreviated Study	
County: Lorain	Route: C.R. 51 (Baumhart Road) and Industrial Parkway
Lorain County Engineer's Office	
Submitted: April 30, 2021	
By: Bramhall Engineering & Surveying Company

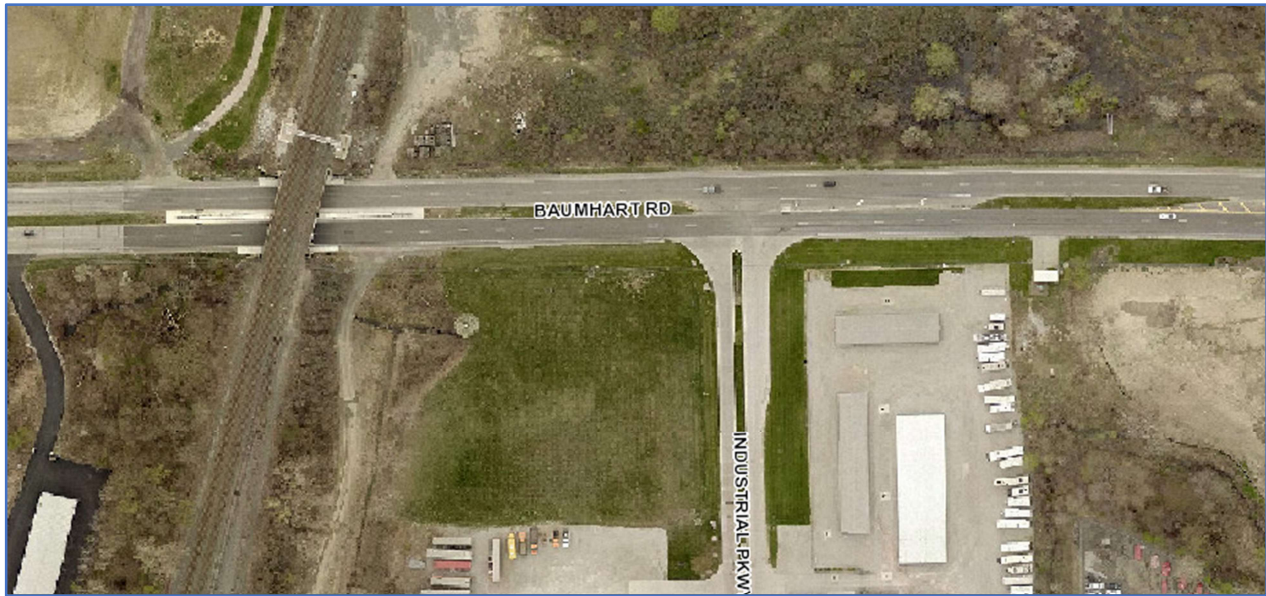
Figure 1 – Baumhart Road and Industrial Parkway

Baumhart Road and Industrial Parkway is a 3-way intersection, with Baumhart Road traffic having the right of way and Industrial Parkway operating under stop control at its intersection with Baumhart Road.

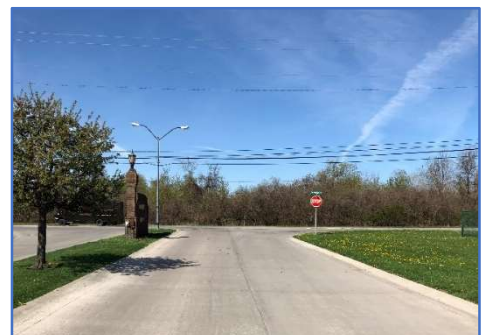
Figure 2- Industrial Parkway looking west

Industrial Parkway is a 2-lane road that provides access to several of the commercial/industrial sites and terminates at Baumhart Road to form a T-intersection operating under stop control. The single stop sign is located almost 40' from the intersection and the stop bar is completely worn away. The Functional Classification is Local Road. Industrial Parkway is a full-movement intersection with access to southbound Baumhart Road provided via a paved median.

The existing stop bar on Industrial Parkway is located almost 40' from the intersection and was extremely faded during our field review. It should be re-striped to be located within the recommended 4'-30' distance from the edge of Baumhart Road. Epoxy pavement marking material may provide a longer service life for this stop bar location.

Dual-mounting the stop signs and installing sign post reflectors should help draw attention to the stop condition and mitigate the occurrences of vehicles entering the intersection without stopping. Adding W4-4P "Cross Traffic Does Not Stop" plates under the stop signs should help remind vehicles on Industrial Parkway that Baumhart Road has the right-of-way.

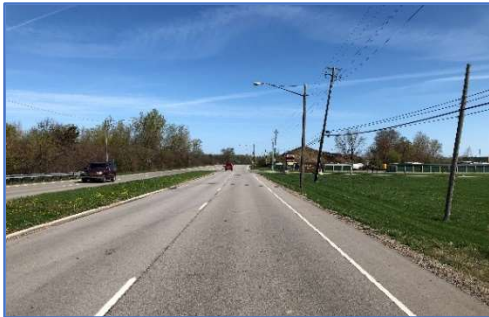
*Figure 3 - Baumhart Road looking north*

Of the crashes, four (4) were Injury crashes, and one (1) was Fatal. It is not surprising that the crashes are more severe due to the 50-mph posted speed on Baumhart Road. While the crash reports do not indicate that any of the Baumhart Road vehicles were speeding, a review of the 85<sup>th</sup> percentile speed indicates that vehicles are travelling in the range of 56-57 mph.

For Baumhart Road, installing W2-2R "T-Intersection" warning signs with supplemental street name plaque for both northbound and southbound traffic may help in alerting Baumhart Road vehicles to the possibility of traffic entering the roadway from Industrial Parkway, so they can react accordingly.

Lastly, the County could consider a speed zone study to determine if a lower speed limit on Baumhart Road is warranted.

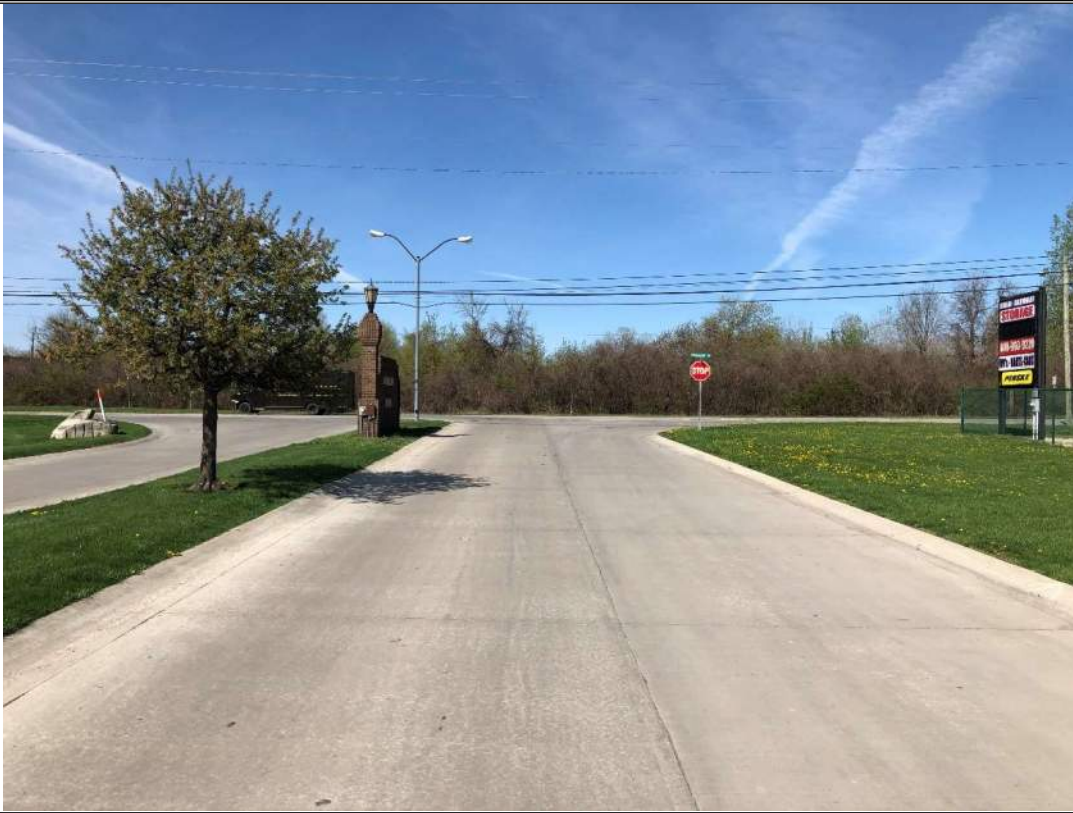
Industrial Parkway – Looking west toward Baumhart Road.

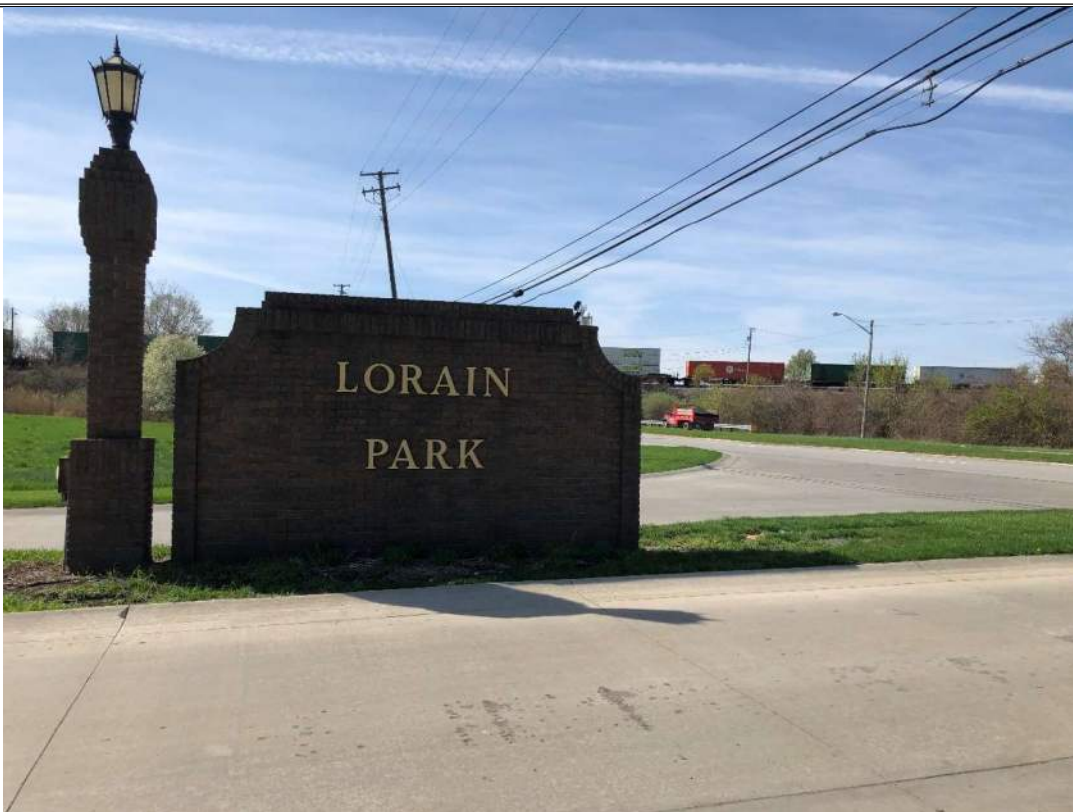
Industrial Parkway – Looking south. Brick sign is approximately 22' long and 11' high.
