SR 611 SAFETY STUDY

Ohio Department of Transportation

BURGESS & NIPLE

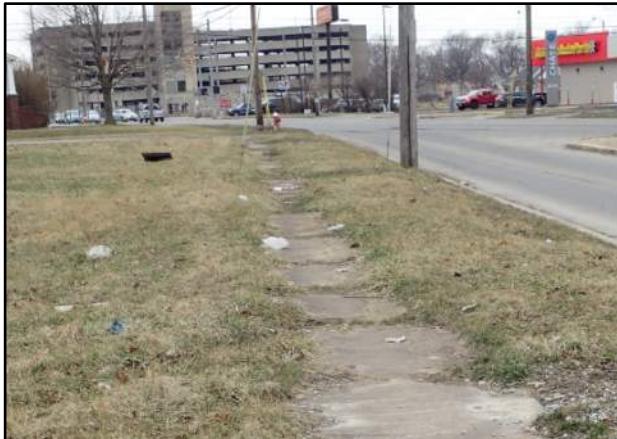
Photo 1: Sidewalk on South Side of SR 611

- **Improve existing sidewalk along the corridor:** Some of the sidewalk is damaged, cracked, or missing along the corridor. Improving the existing sidewalk is proposed.

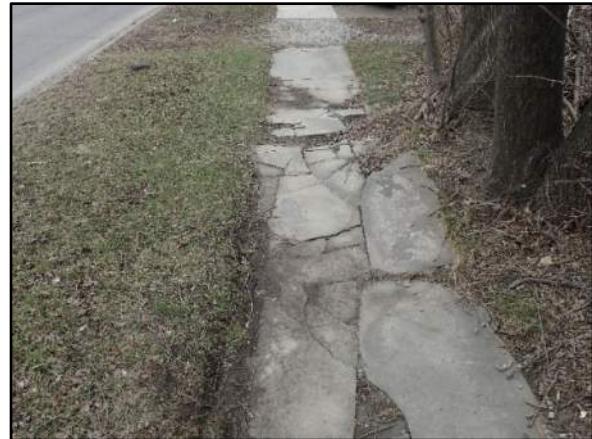
Photo 2: Sidewalk on North Side of SR 611

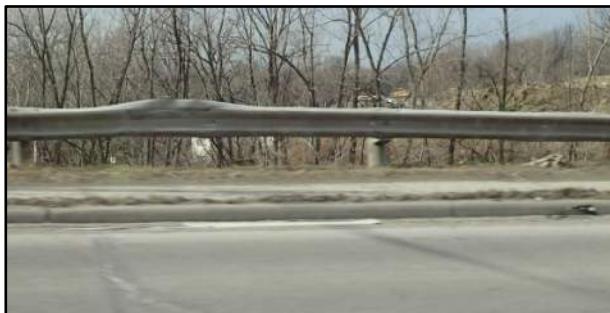
several dents. Some of this damage is shown in **Photo 3**. On-street parking is not provided along SR 611. Pedestrian railings are provided on either side of the railroad underpass.

Photo 3: Guardrail on West Side of SR 611

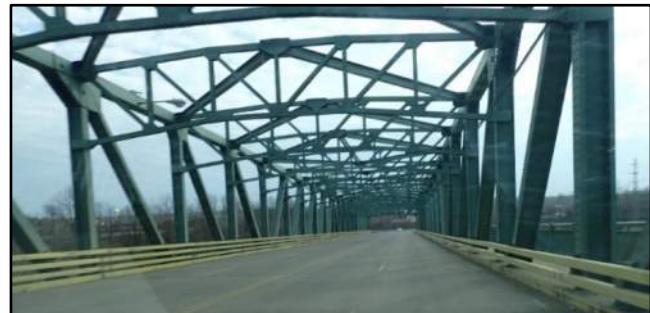
The Lofton Henderson Memorial Bridge over the Black River is an area of concern due to the curvature and grade on both of the bridge approaches, narrow 10-foot lanes, and lack of shoulders, shown in **Photo 4**. These roadway characteristics create little room for driver error. Pedestrians, bicyclists, and dirt bike drivers were observing using the sidewalk on the west side of the bridge to cross the river.

Photo 4: Lofton Henderson Memorial Bridge

- **Add speed radar feedback signs on the approaches of the Lofton Henderson Memorial Bridge:** Several of the injury crashes and all the fatal crashes have been related to vehicles speeding along the corridor, especially on the Lofton Henderson Memorial Bridge. Speed radar feedback signs are proposed on the approaches of the Lofton Henderson Memorial Bridge to encourage drivers to slow down through the corridor.

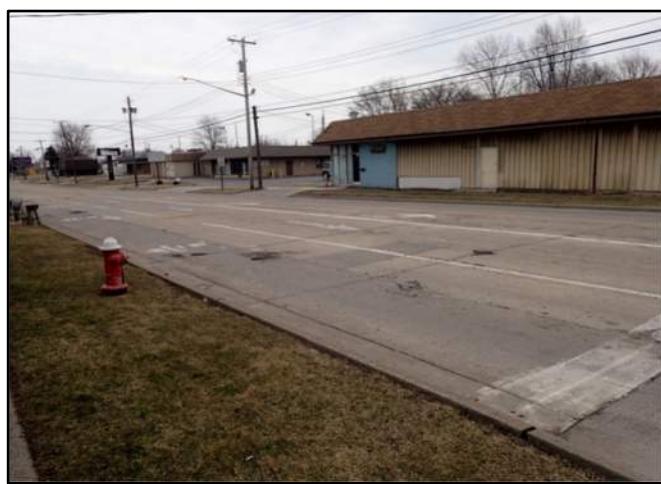
Photo 5: Faded Pavement Markings at Kansas Avenue /Colorado Avenue Intersection

- **Improve pedestrian facilities:** Pedestrian improvements such as pedestrian signal heads, push buttons, and high visibility crosswalks are proposed to improve pedestrian safety.
- **Improve pavement markings:** Restriping the pavement markings is proposed due to the faded lane-use pavement markings throughout the intersection.

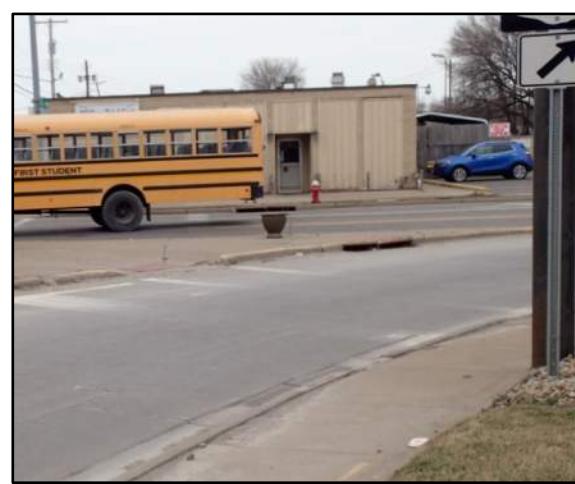
Photo 6: Faded Crosswalk Markings at Kansas Avenue /Colorado Avenue Intersection

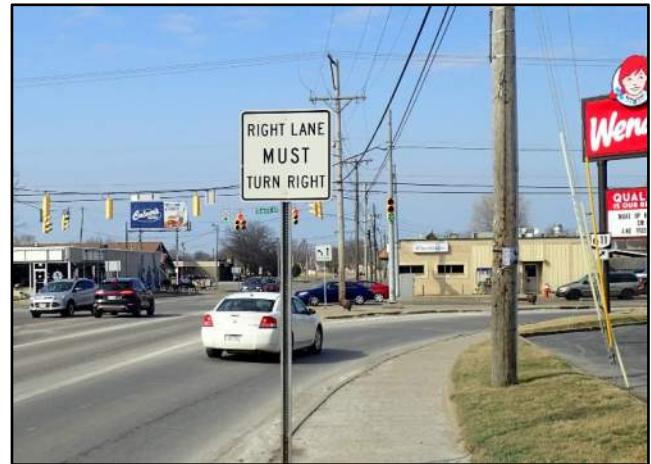
Photo 8: Wendy's Sign Blocking Pedestrian Sight Distance at Kansas Avenue /Colorado Avenue Intersection

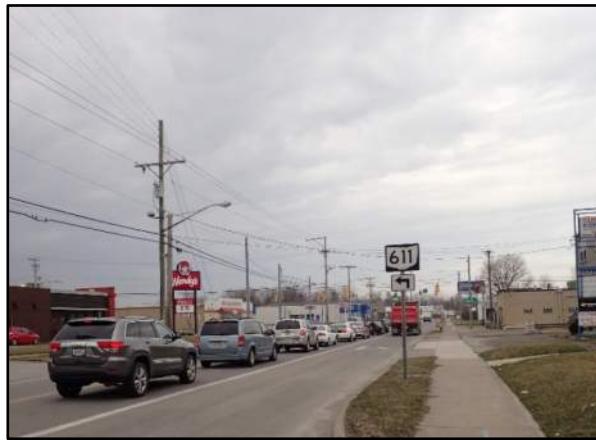
Photo 9: Queuing in Eastbound Left-Turn Lane at Kansas Avenue /Colorado Avenue Intersection

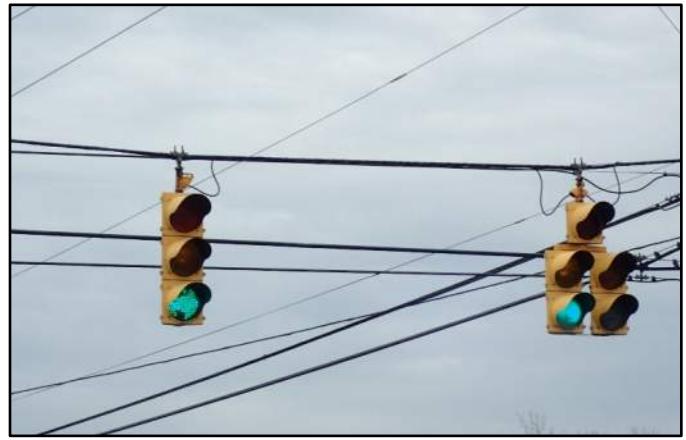
The lane configuration for this signalized intersection is illustrated in **Figure 2**. The current signal is a four-sided box-span configuration. The northbound and westbound approaches have protected/permissive left-turn signal phasing, the eastbound approach has permissive left-turn signal phasing, and the southbound approach has protected left-turn signal phasing. The northbound and eastbound approaches have right-turn overlap phases. The lane use pavement markings are faded throughout the intersection, shown in **Photo 5**. Pedestrian signal heads and push buttons are not provided at the intersection. Crosswalks are striped on all approaches. The crosswalk striping across the northbound right-turn slip lane was very faded, shown in **Photo 6**. Pedestrians were observed traveling through the intersection, shown in **Photo 7**, especially after school release to travel to the fast-food establishments on the east side of SR 611. The Wendy's sign and utility pole on the northbound approach obstructs the pedestrian crossing location across the slip lane, shown in **Photo 8**. Pedestrians must be vigilant while crossing the slip lane as many vehicles are not slowing down or looking for pedestrians. During a site visit, traffic was observed queuing in the eastbound left-turn lane, shown in **Photo 9**, but all traffic was able to get through the intersection each cycle. Intersection lighting is provided at the intersection. A few of the traffic signal heads have some damage to the lens, creating signal visibility issues as shown in **Photo 10**.

Photo 10: Damaged Eastbound Signal Heads at Kansas Avenue /Colorado Avenue Intersection

- **Rebuild traffic signal:** Rebuilding the traffic signal is proposed to improve signal visibility. Retroreflective backplates are recommended on all signal heads in the rebuild of the traffic signal.

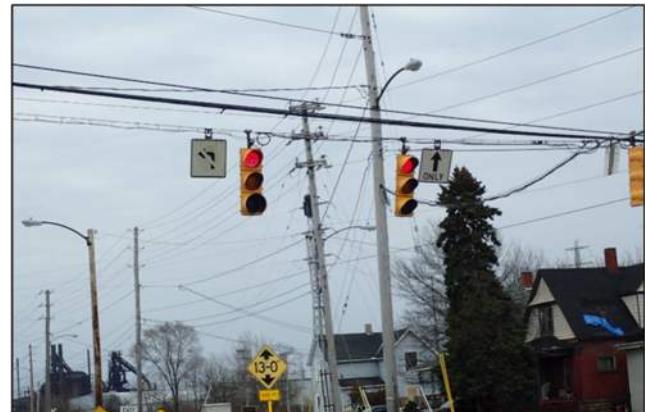
Photo 11: Faded Turn Lane Signage at SR 611 and Elyria Avenue

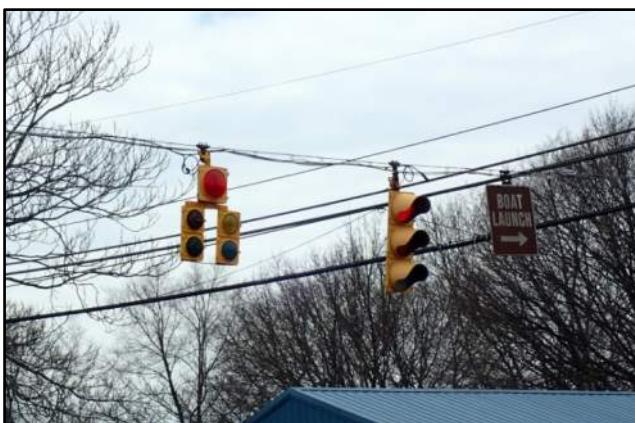
Photo 12: Non-Traditional Signal Head at SR 611 Elyria Avenue

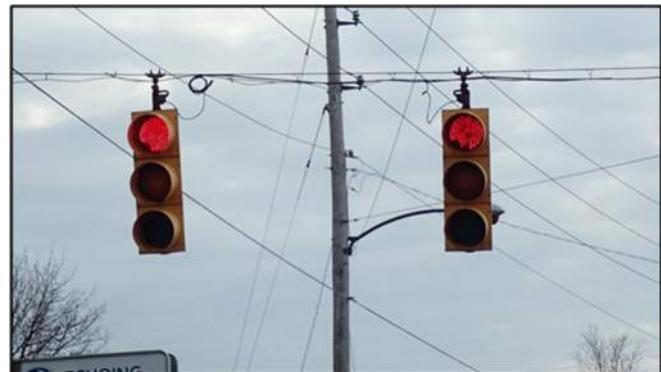
Photo 13: Damaged Signal Lens at SR 611 and Elyria Avenue

The traffic signals at the intersections of SR 611 with Elyria Avenue/E 21st Street and Broadway are both in the process of being redesigned and rebuilt.

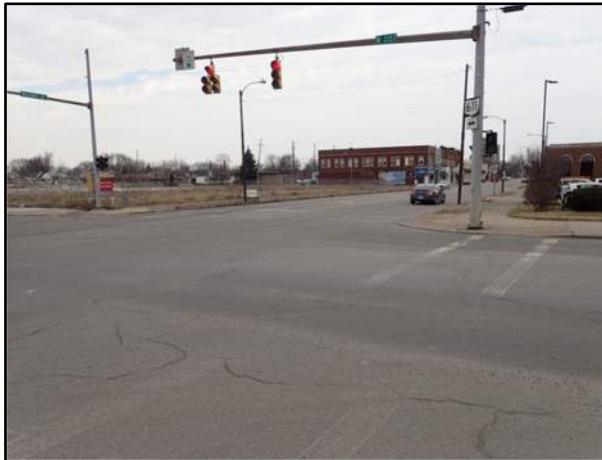
Photo 16: Faded Crosswalk Markings at SR 611 and Broadway

- **Stripe high visibility crosswalks:** High visibility crosswalks should be striped on all legs of the intersection. This improvement will be funded through an ODOT D12 pedestrian safety project, awarded in May 2022.
- **Modify stop bar placement:** Truck turns were run at the intersection, and it was found that to accommodate a semi-truck through the intersection, the stop bar on the west leg should be shifted to the west 30 feet.
- **Improve pavement markings:** Restriping the pavement markings is proposed due to the faded lane-use pavement markings throughout the intersection.

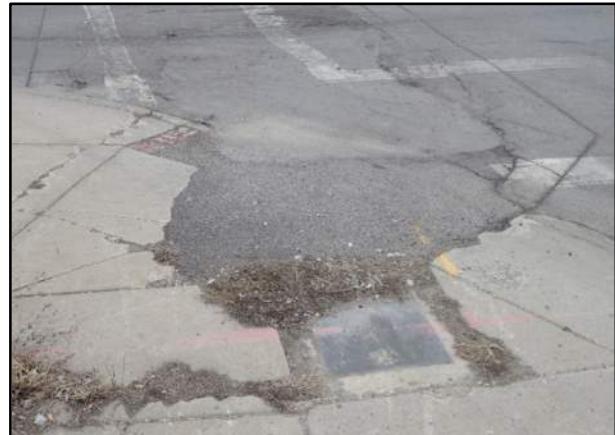
Photo 17: Northwest Corners Curb Ramps at SR 611 and Broadway
